Completion of Performance Evaluations of Preproduction Prototypes

Deliverable Number: 12.C.2

Task 12.C.2: Completion of Performance Evaluations of Preproduction Prototypes

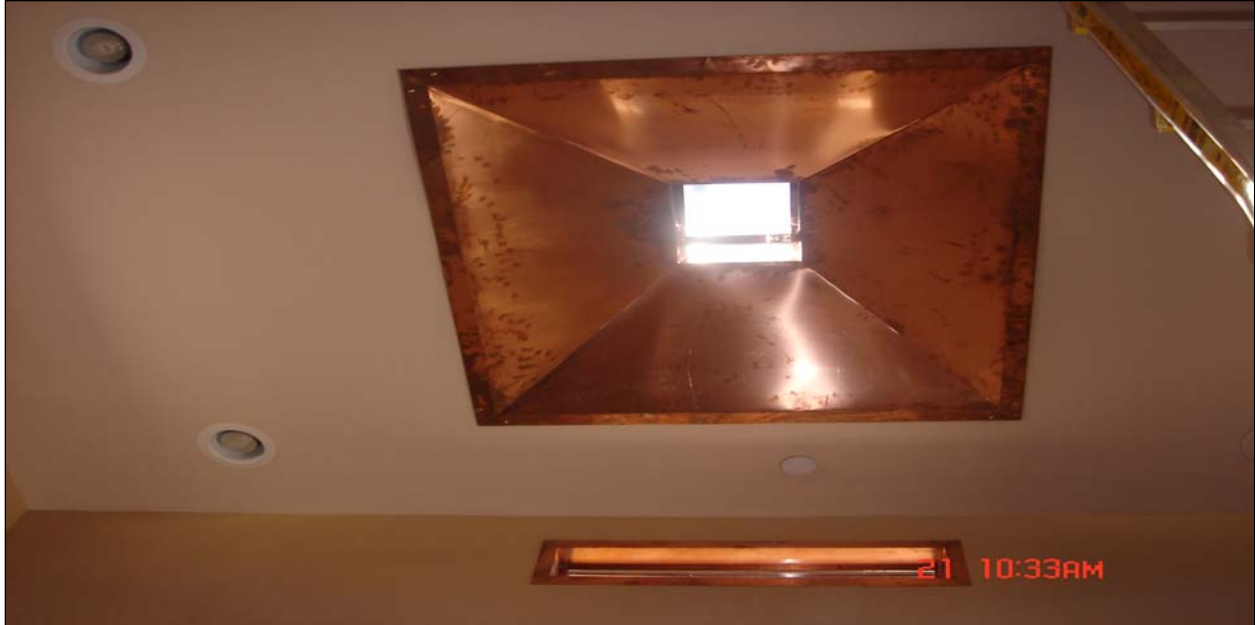
Figure 6: Example Custom, Site Built Ceiling Skylight Penetrations

Third-Party testing was done on each home to verify duct leakage and air infiltration. Broken Arrow passed with a leakage of 4.5% and East Star passed with a duct leakage of only 2%. Both homes had problems with air infiltration. Initial tests of the homes resulted in SLA values of close to five. The design Clarum/BIRA goal for these homes required were seeking an SLA's of two. It was determined, after numerous hours of troubleshooting, that both homes had the same problems. The problems were largely the a result of numerous architectural penetrations of all skylights and windows were custom, built on site such as those shown in Figure 6 and 7.

It became very apparent that the decorative custom built windows and skylights had not been properly installed and sealed to prevent air leakage. Once the project manager was instructed on proper measures, the homes were re-tested and found to have an SLA of approximately four. This was a marked improvement, but lower than the performance level originally intended. Clarum takes full responsibility and has carefully noted this lesson learned to avoid problems on future projects.

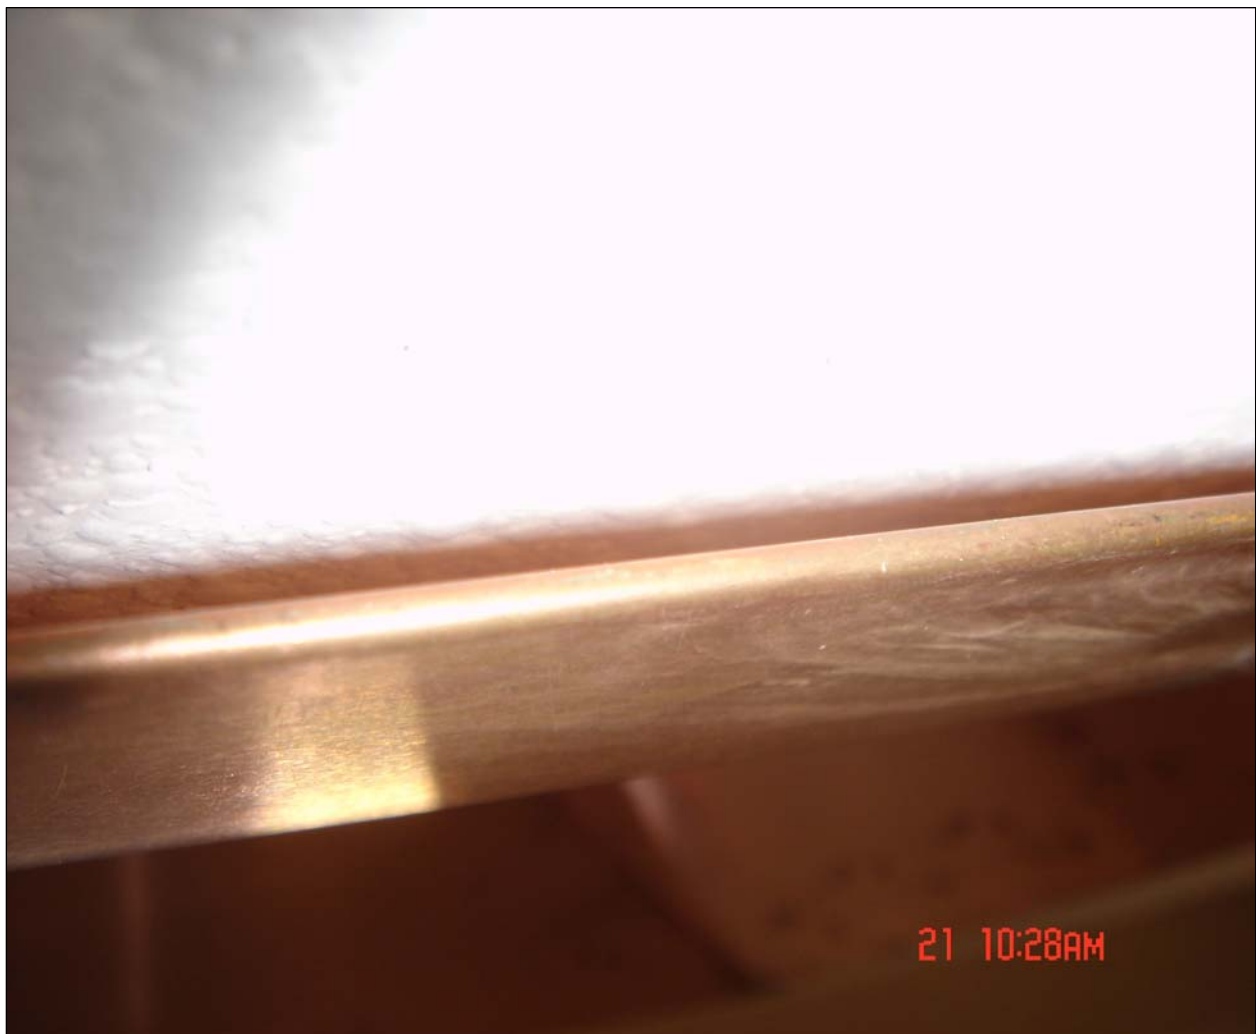
Figure 8: Close-up View of Skylight Perimeter

Figure 8 shows the perimeter of the skylight shown above in Figure 5. Essentially, the large 4x4 skylight was not caulked to the drywall allowing air infiltration on all sides coming from the attic space. Once the project manager was instructed on proper measures, the homes were re-tested and found to have an SLA of approximately four.

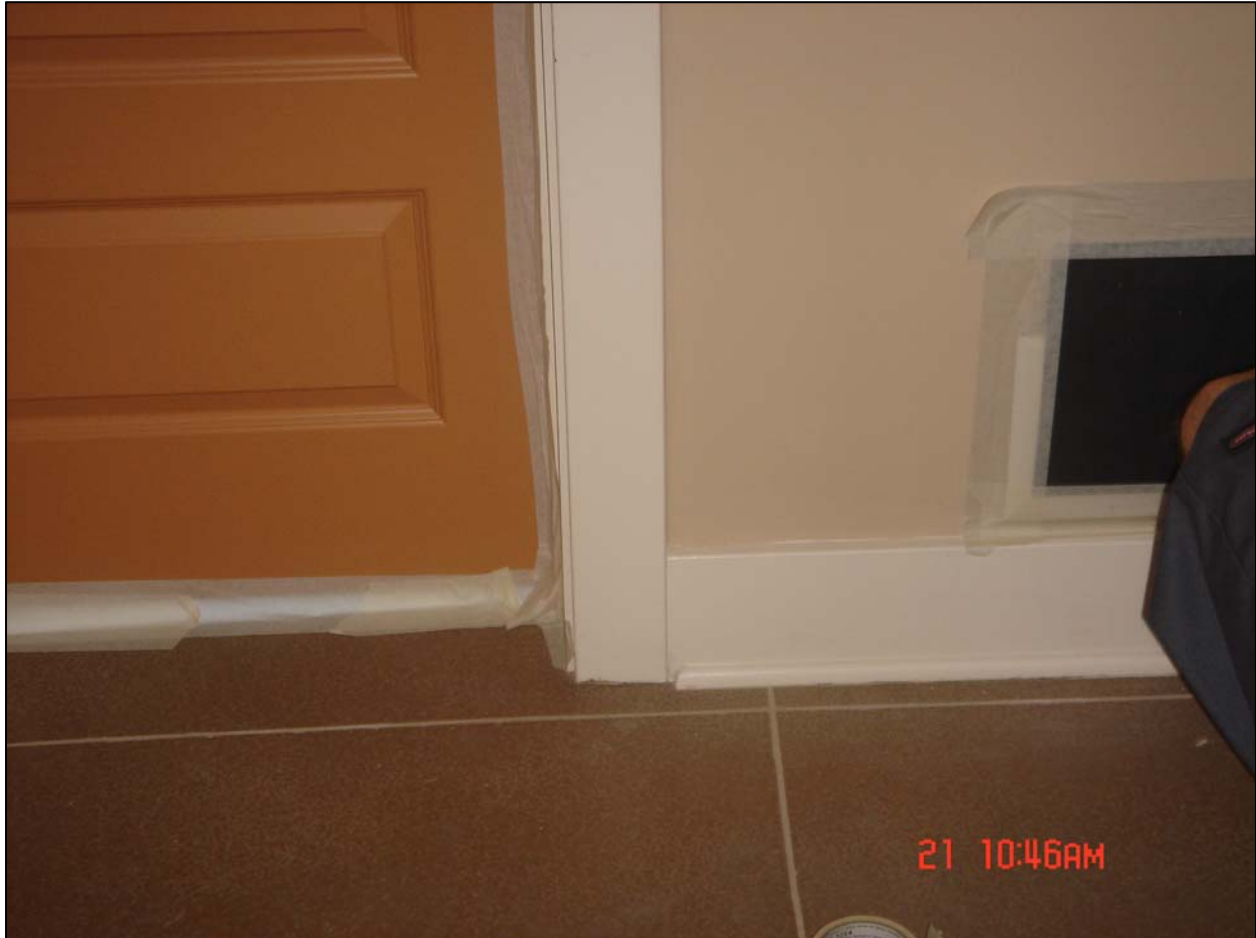
Figure 9: Floor to Wall Infiltration Gap

On further inspection, the reason for continued air infiltration was found in the baseboards, shown in Figure 9. Air was infiltrating from the attic air space through the stud bay of the interior walls and entering into conditioned space between the gaps created where the interior wall meets the slab. After caulking all the interior wall baseboards, SLA's dropped to reasonable, yet still not our projected level of air infiltration as seen from Test and Inspection results in Appendix A.

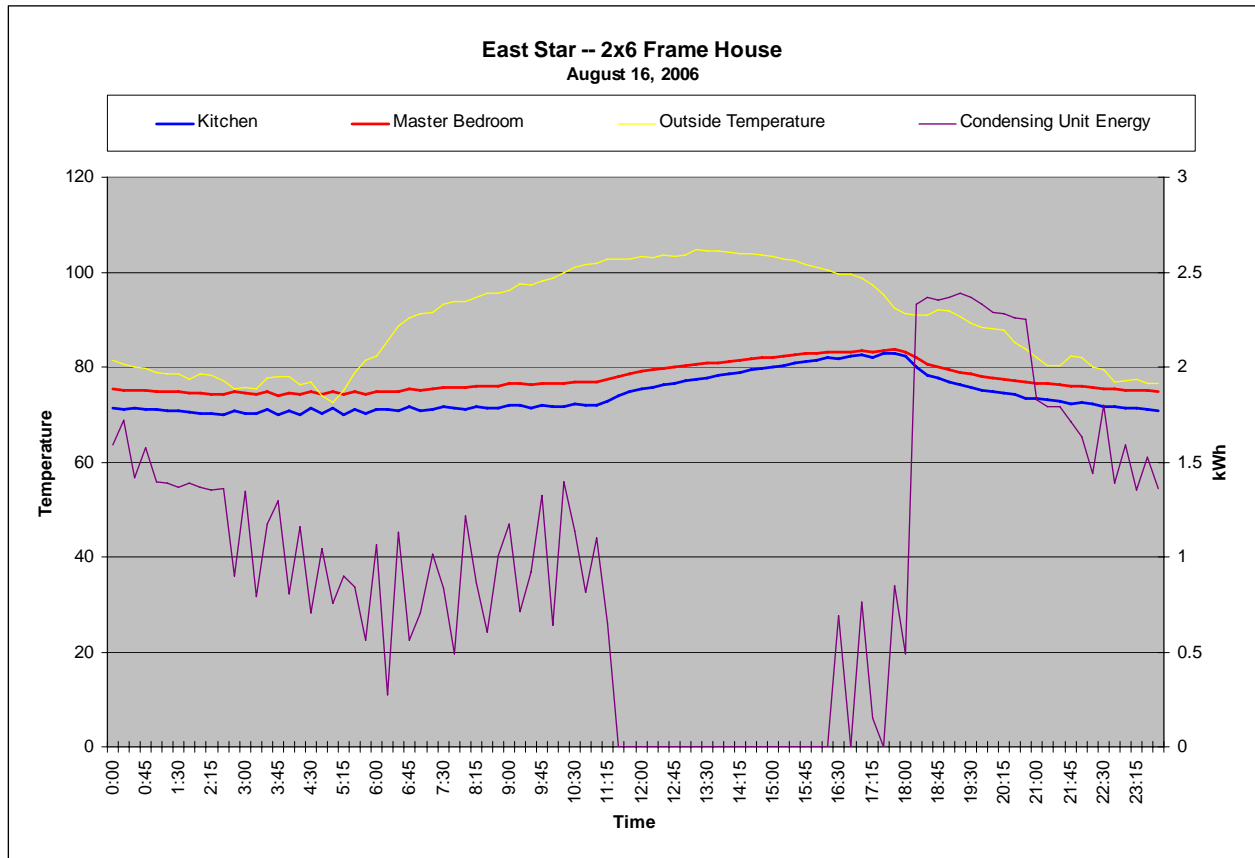
Figure 13: Super-Cooling Experiment – 2x6 Frame House

Figure 13 shows the interior temperature of the Master Bedroom and Kitchen along with the Condenser Energy Use for the 2X6 Frame house. In this case, when the HVAC system is set to 85°F from 12 PM to 12 AM, the interior temperature change is approximately 8 degrees, but never reaches 85°. The HVAC system begins to run around 4 PM and runs continuously through the night.

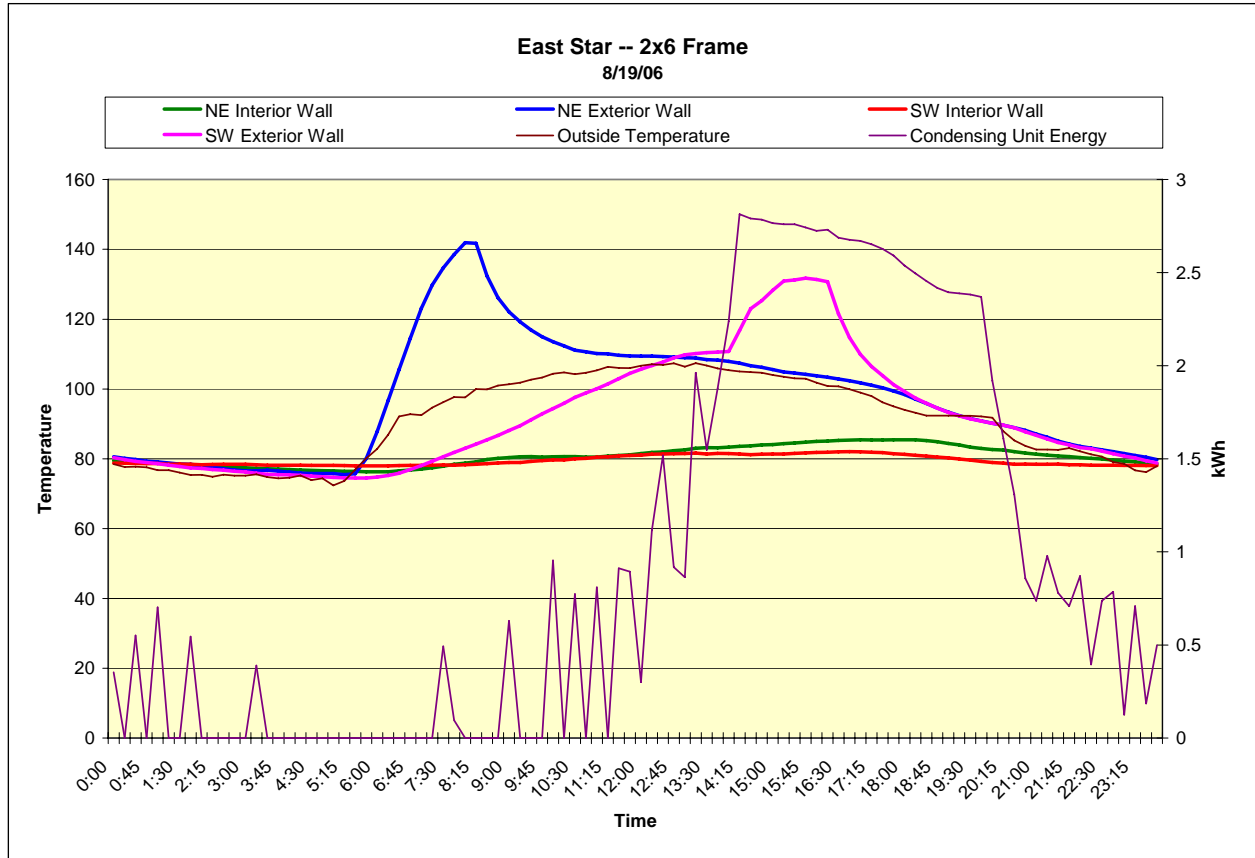
Figure 17: 2x6 Frame Wall Performance -- 78° Set Point

When compared with the 2x6 Frame house, during peak afternoon hours, the T-Mass cooling system runs from 3PM until 7PM . The 2X6 Frame house begins running at 2PM and run until 9PM to maintain the 78° set point.
